Manhole Inspection Summary

Manhole # S53Y1_004MH

Inspection ☐ Is Incomplete Rating: **4) Poor**

Insp Date: **4/23/09 12:09 PM**

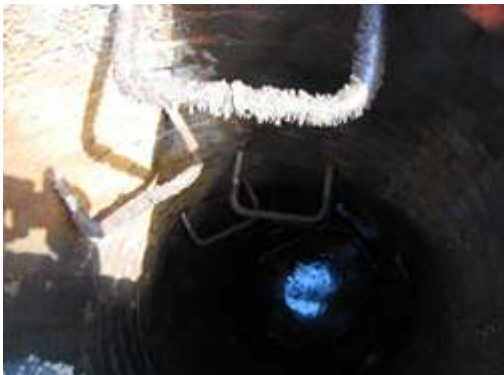
Steps

Count: **14** Missing: **0** ☐ Corroded

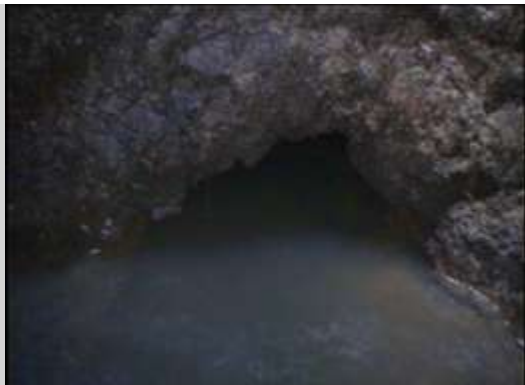
5 O'Clock Inflow

24 in. Circular Gravity Sewer
Pipe In @ 5 O'Clock

Pipe Height: **19.2** (in.) Rod and Bar (Angled)
Pipe Material: **Unknown** ☐ Pipe Lined
Invert Depth: **15.80** (ft.) Flow Characteristics: **Slow**
Deposits: ☐ None ☐ Mud ☒ **Sludge** ☐ Debris ☐ Grease
Silt Depth: **6** (in.) Deposits Extent: **Heavy**
Infiltration: **Evidence** Pipe Seal Cond: **Unknown**
